RESTORATION AND UPGRADE OF A PAPER MILL'S ELECTRICAL GENERATING SYSTEM— A CASE STUDY OF BROWNVILLE SPECIALTY PAPER PRODUCTS

Abstract - This restoration and upgrade project was undertaken based on the need to replace the excitation system, generator protection, synchronizing control and circuit breaker of Brownville Specialty Paper Products' 875 kVA, 480 volt paper mill generator. The project was prompted by an electrical fault, which occurred on the generator feed and resulted in a fire. The fire event is described as well as a fault description and the resulting damage. The general effect of the loss of the steam turbine generator on the mill is discussed, including the incremental energy costs for mill operation. This paper identifies the necessary repairs and replacements required to return the steam turbine and generator to service and thoroughly discusses the mill operational and protection advantages obtained through the upgrade project.

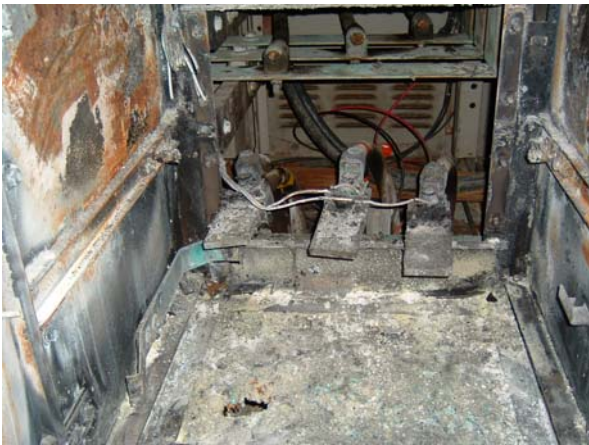
The fire destroyed the voltage regulator and field circuits, the breaker and cubicle, the limited protection, and the synchronizing control. There were four other 1600 amp breakers in the switchgear line-up that also had to be removed, cleaned, and repaired. The bus work and wiring in the switchgear had to be cleaned and repaired before the mill was able to run.

Figs. 2, 3 and 4 document examples of the extensive damage to the equipment and systems in the fire.

Fig. 2 Damaged Breaker Cubicle

Due to the extensive damage, the protection, synchronizing control, and excitation control also needed to be replaced. The switchgear cubicles that included the breaker, associated protection, synchronizing and excitation control were damaged beyond repair. Additionally, the generator power lead cables suffered significant damage and needed to be replaced. All associated instrument transformers, control power transformers, protection and control cables were damaged beyond repair and also needed to be replaced.

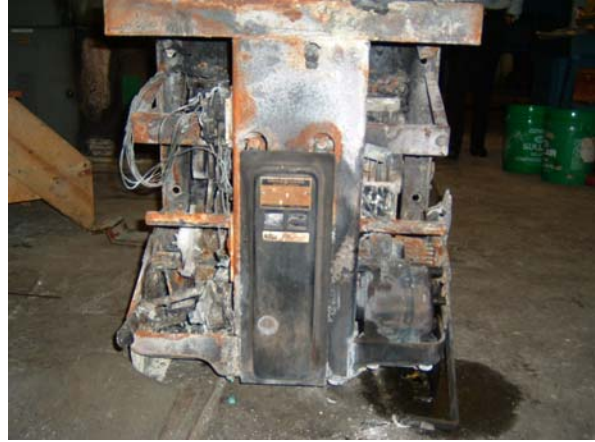
On the evening of August 15, 2005, a fault and resulting fire occurred that damaged the 875 kVA generator and its associated equipment. It is thought that the fire was caused by a short—caused by worn or damaged insulation on the six 750 mcm cables running between the generator and the AK1-50 1600 amp breaker that connects the generator to the mill electrical distribution system. This fault was between two phases on this section of cable run. The phase-to-phase fault and its duration caused the contacts on two phases of the generator breaker to weld together and would not allow the generator to be cleared from the mill electrical system. The only protection in place was the breaker's long time element that had significant delay. Therefore, the breaker did not trip prior to the contacts welding together on the faulted phases. The generator continued to feed energy into the fault for some time. This was due to the failed breaker, the lack of an automatic shutdown of the turbine generator system, and the resulting generator decrement current due to the fault. The mill's main 3000-amp breaker was opened and isolated the mill electrical system from the utility supply without incident. When the mill power was shut down, the oil pump feeding the turbine valve controls and field excitation control also shut down. The turbine valve was forced to close, removing the steam supply when the oil supply was eliminated. In addition, the field excitation decayed in time when the control was lost during the mill power shutdown. The generator stopped feeding electrical energy to the fault after the steam and field were removed.

Fig. 3 Extensively Damaged Generator Breaker

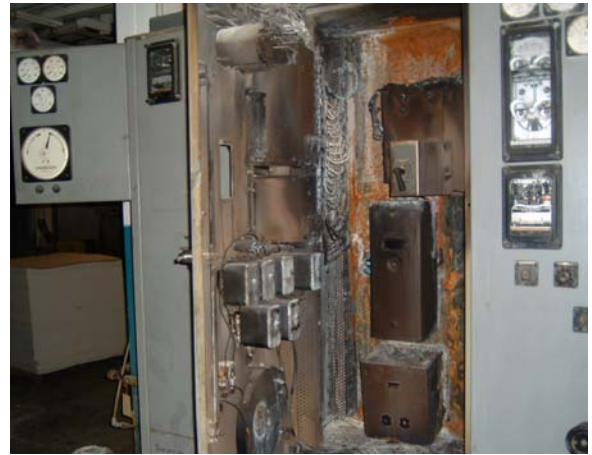
Fig. 4 Damaged Excitation Control and Synchronizing Equipment and Metering

All of the associated generator system equipment damaged in the fault/fire event was replaced and upgraded to state-of-the-art systems. The rotating exciter was replaced based on its age and due to the inability to further undercut the commutator for additional service life. Due to the fire, the excitation controls were damaged beyond reuse. A static excitation system including the voltage regulator was provided; significant performance as well as greater flexibility in operation was obtained.

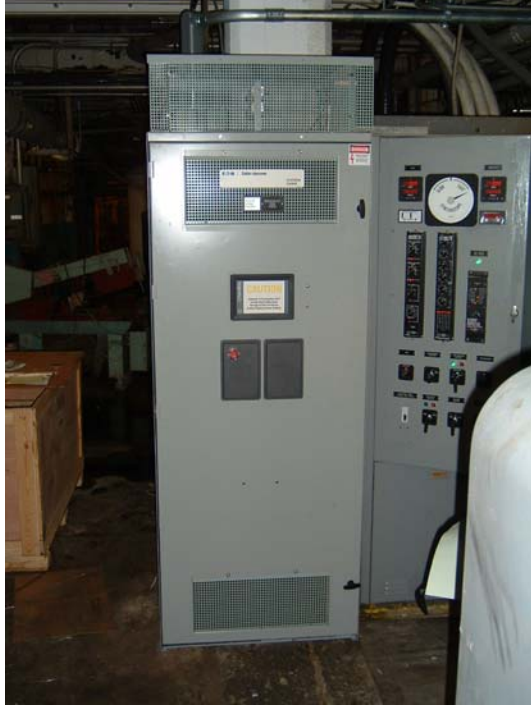
Fig. 5 Static Excitation System

As stated, as much of the existing infrastructure and equipment was reused. The excitation system was essentially replaced with a static excitation system, shown

in Fig. 5. A new cubicle containing this system was installed next to the existing switchgear line up.

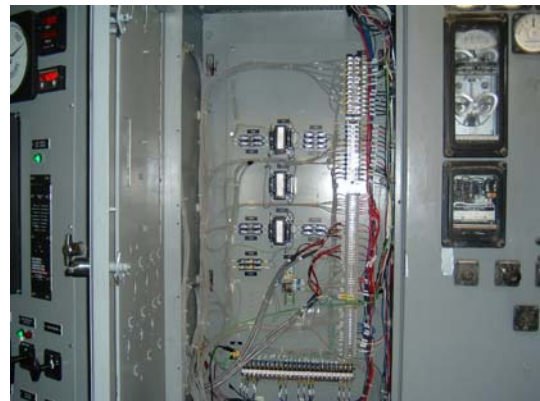
Fig. 6 Internal Sub-Panel for Protection and Control Circuits

Fig. 6 shows the internal sub panel mounted into the cleaned switchgear cubicle. This panel includes the instrument transformers and interconnecting terminals for field wiring and other interconnections between systems.

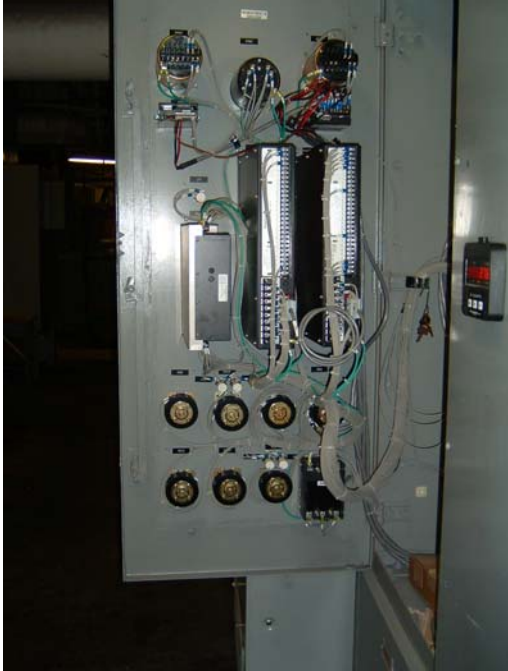
Fig. 7 Back of Protection and Synchronizing Control Sub-Panel

In Fig. 7, the back of the protection and synchronizing control system sub-panel is shown mounted into the cleaned front door of the switchgear.

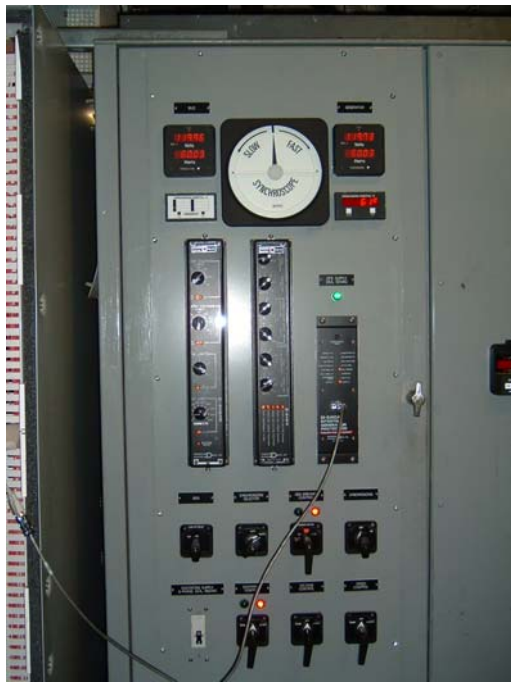
Fig. 8 Front of the New Protection and Synchronizing Control Sub-Panel Installed

Fig. 8 shows the front view of the new completed protection and synchronizing control equipment mounted on the switchgear door. This includes the digital Integrated Protection System, Synchronizer Unit, Generator Control Unit, synch scope, metering, and control switches.

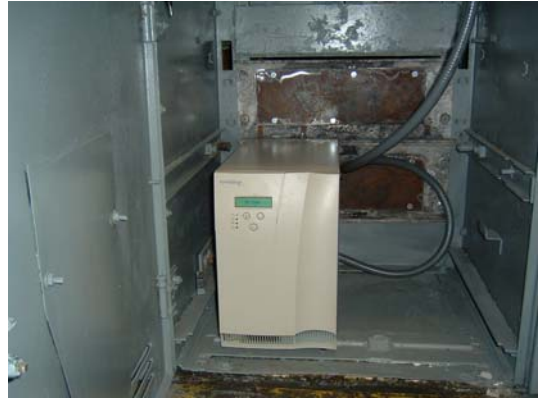
Fig. 9 UPS System Installed in Switchgear Cubicle

An uninterruptible power supply (UPS) system was provided and is shown in Fig. 9. This system was added to

provide emergency power to shut down the unit in the event of the loss of plant power. Adding this UPS enhances the protection and safe shutdown of the turbine-generator and associated equipment.

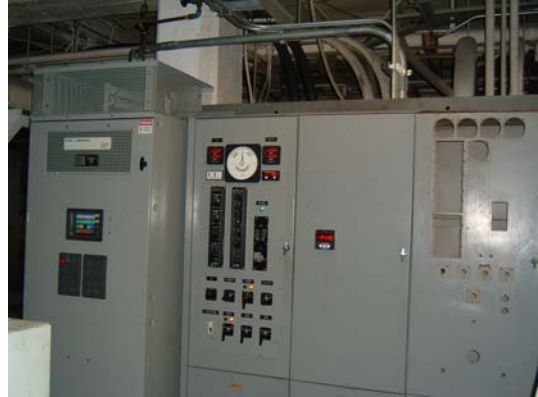
Fig. 10 Completed Retrofitted Switchgear Showing Excitation, Protection and Synchronizing Control Systems

Fig. 10 shows the overall completed retrofitted switchgear with the new systems. Using sub-panels with self-contained wiring facilitated the field installation as the wiring in the sub-panels was completed and checked out in the factory. Only the field-run wiring and interconnections needed to be completed and checked out in the field. This expedited the work in the field tremendously and left less room for error.
